## **ARBORICULTURAL REPORT: ARBORICULTURAL IMPACT ASSESSMENT and ARBORICULTURAL METHOD STATEMENT**

**Brockley Hill, Stanmore, HA7 4LR -  
New Banqueting Facility**

January 2021

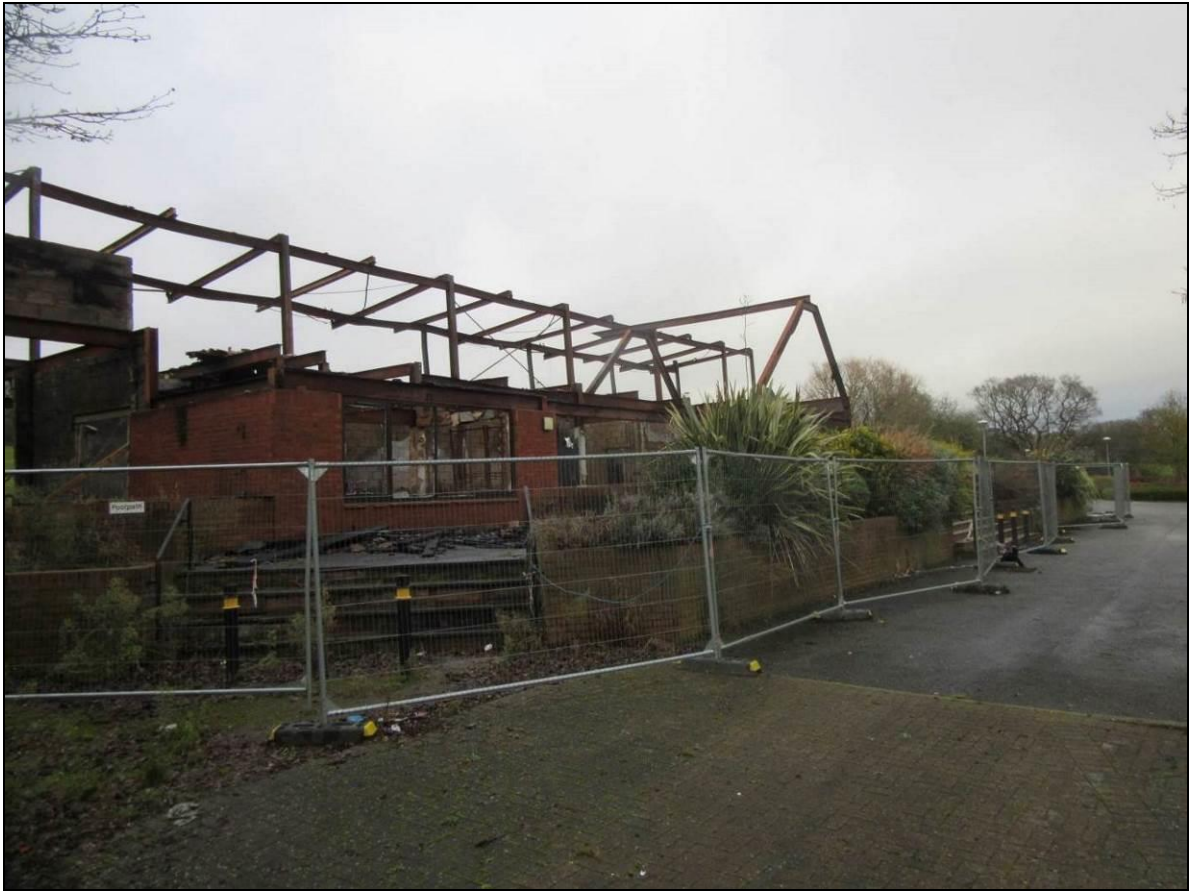
Photograph A – Showing the remnants of the existing building.

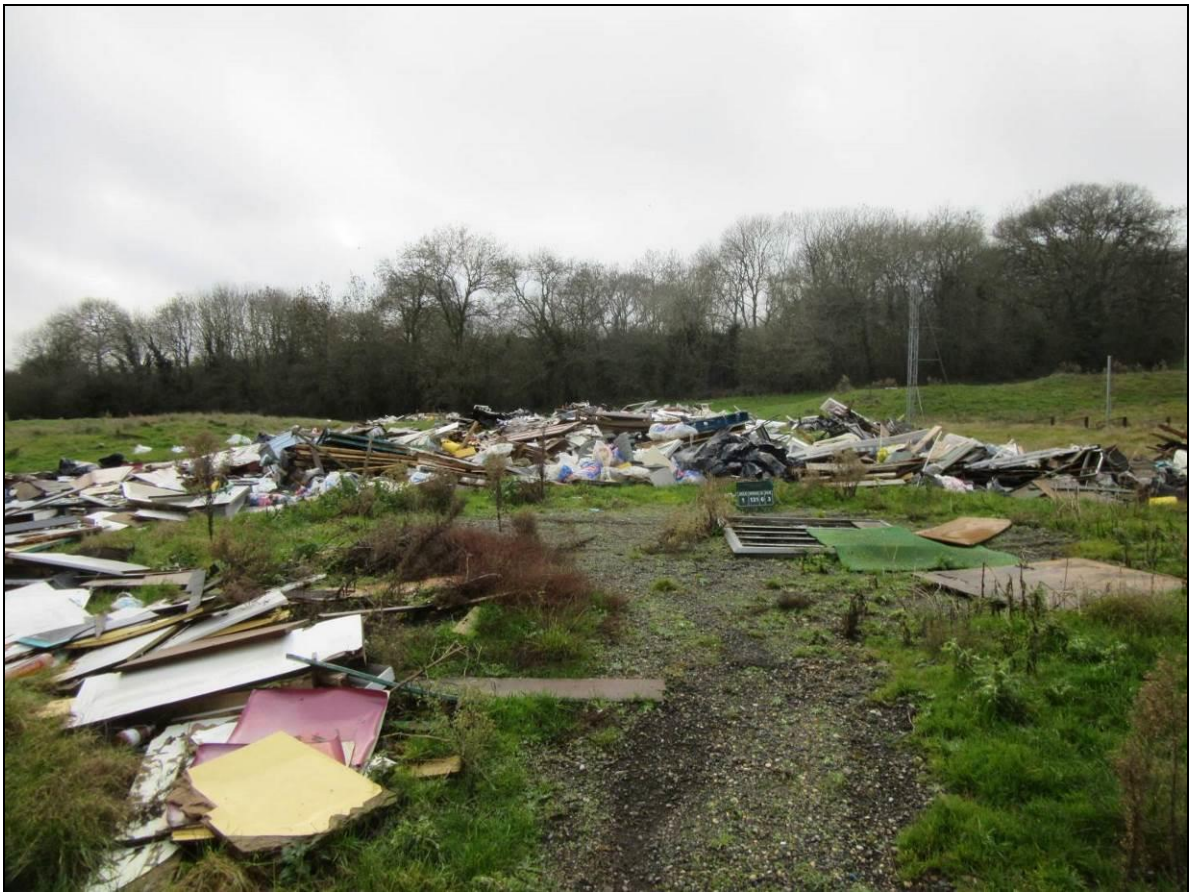
Photograph B – Showing recent fly-tipping within the site.

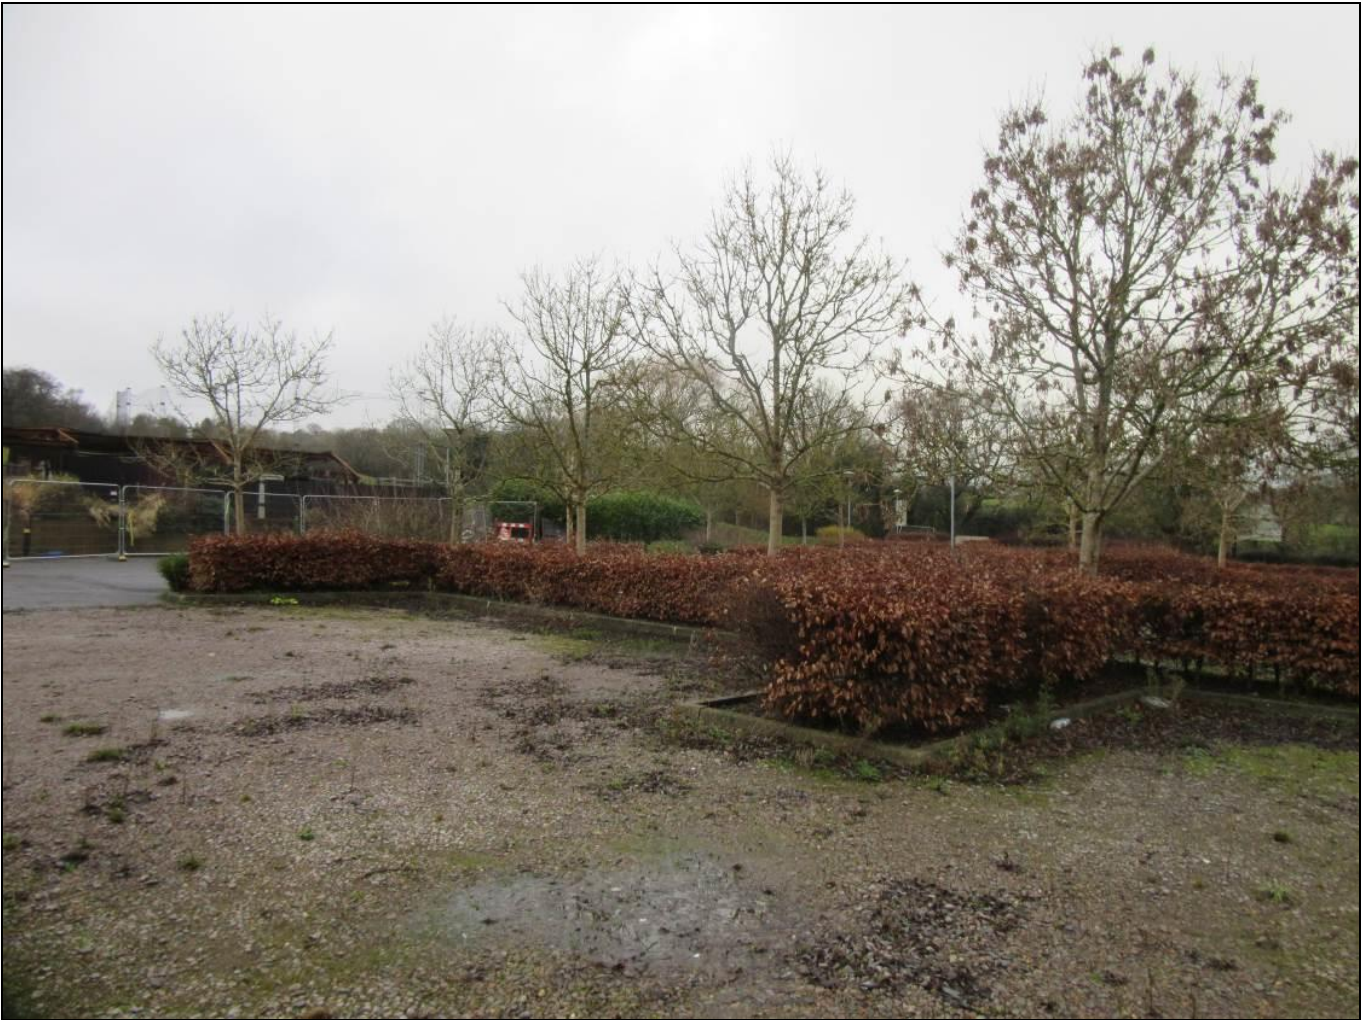
Photograph C – Showing trees and hedging within the existing car park area.

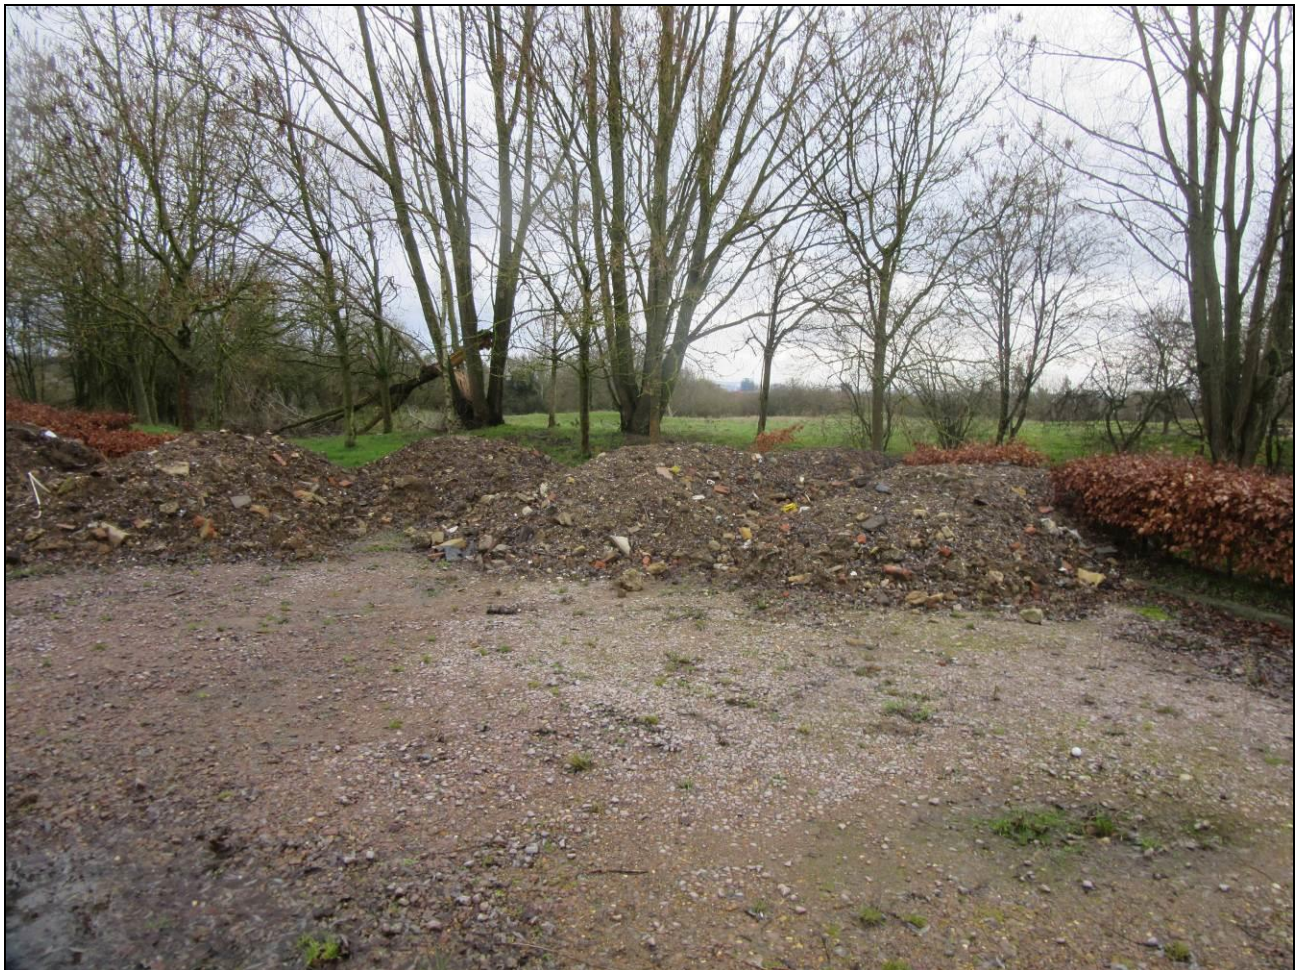
Photograph D – Showing fly-tipped soil within the existing car park area.

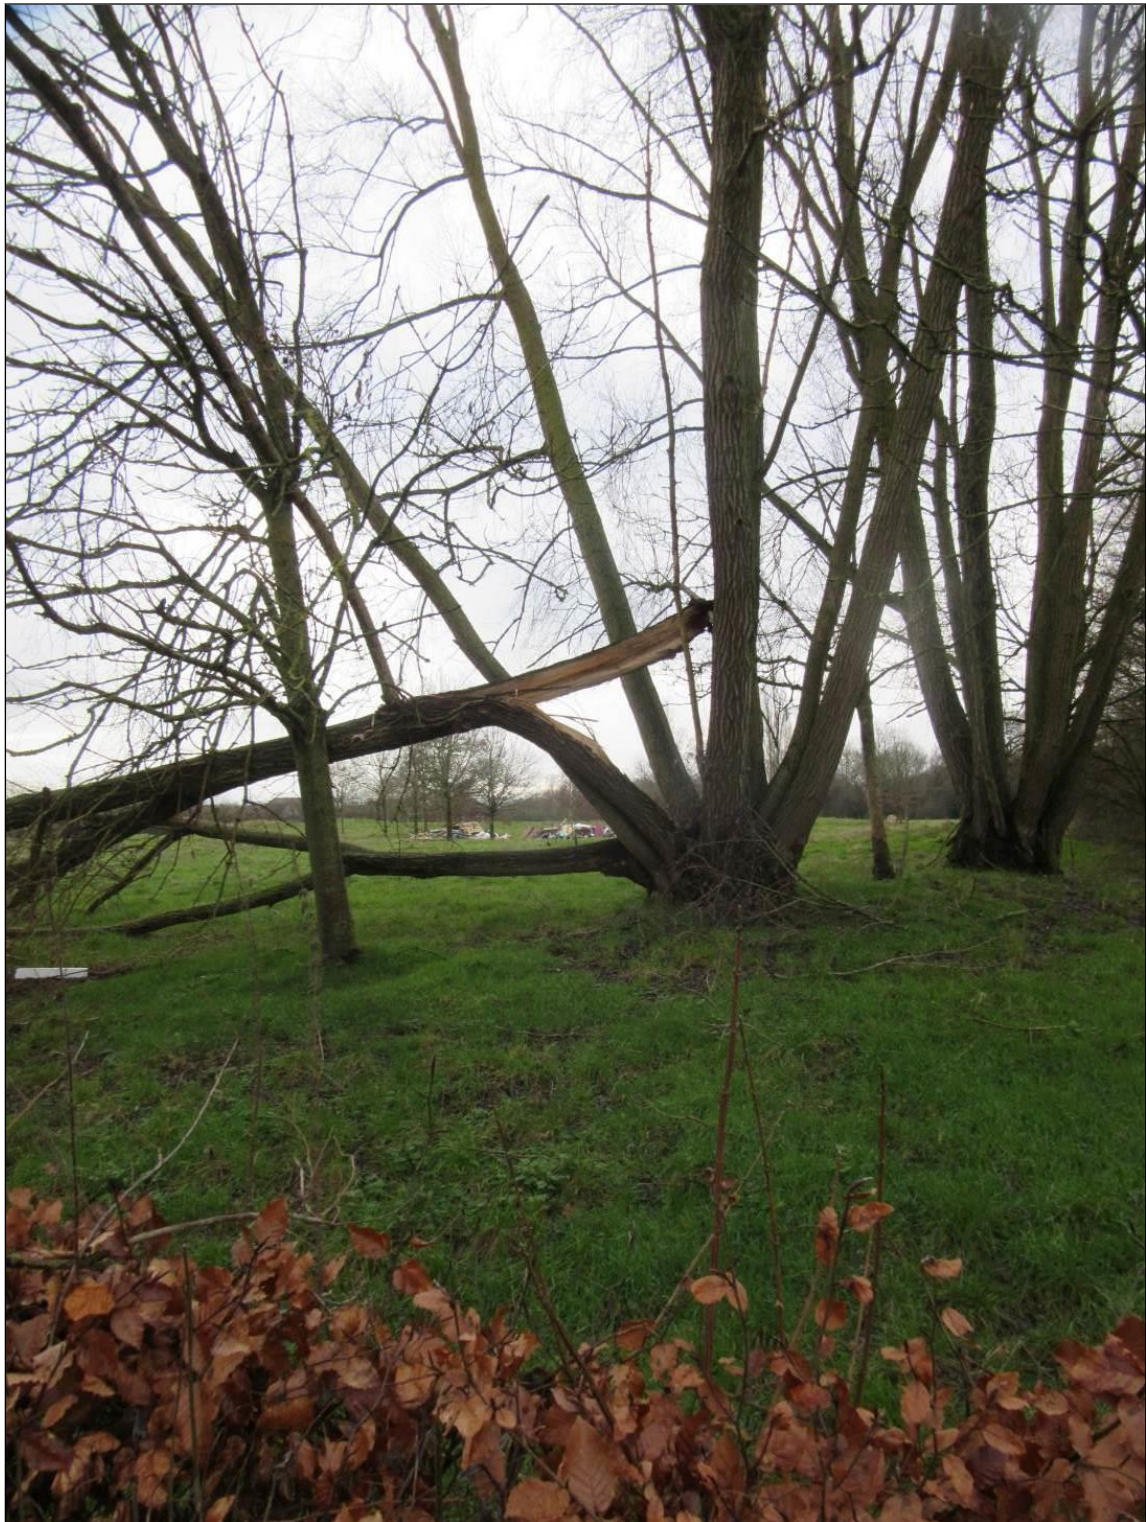
Of the trees within this report a tree within a group (G6) is recommended for removal irrespective of the planning application. Additionally a limb of the Willow to the eastern end of G5 has recently failed around a previously identified crack or split at its base. This defect may affected the structural integrity of the remaining limbs and may expose the remaining limbs to windthrow. The tree therefore presents a potential risk to users of the adjacent car park. It is recommended that the tree is further assessed at the earliest opportunity to assess its stability and structural integrity. These will guide the future management of this tree: either a significant canopy reduction to remove weight loading on the weakened area or the removal/ 'coppicing' of the tree and the planting of a suitable replacement. It is also noted that several trees within G7 have damage – probably squirrel

Photograph E – Showing failed limb to base of Willow (G5).

<u>Tree No.</u>	<u>Species (Common Name)</u>	<u>BS Category</u>	<u>Reason for recommended removal</u>
G5	1 no. Willow (part of group)	U/C2	Possible due to failed limb to base of tree which affects its ongoing viability in this area.
G6	1 no. Birch (part of group)	U	Dead.

- 19.2 Of the trees within this report a dead tree (Birch) within G6 and a Willow within G5 (to be confirmed following further investigations) are recommended to be removed for arboricultural reasons irrespective of this planning application. It is noted that the management of damaged trees may require their removal in the future depending on their viability.

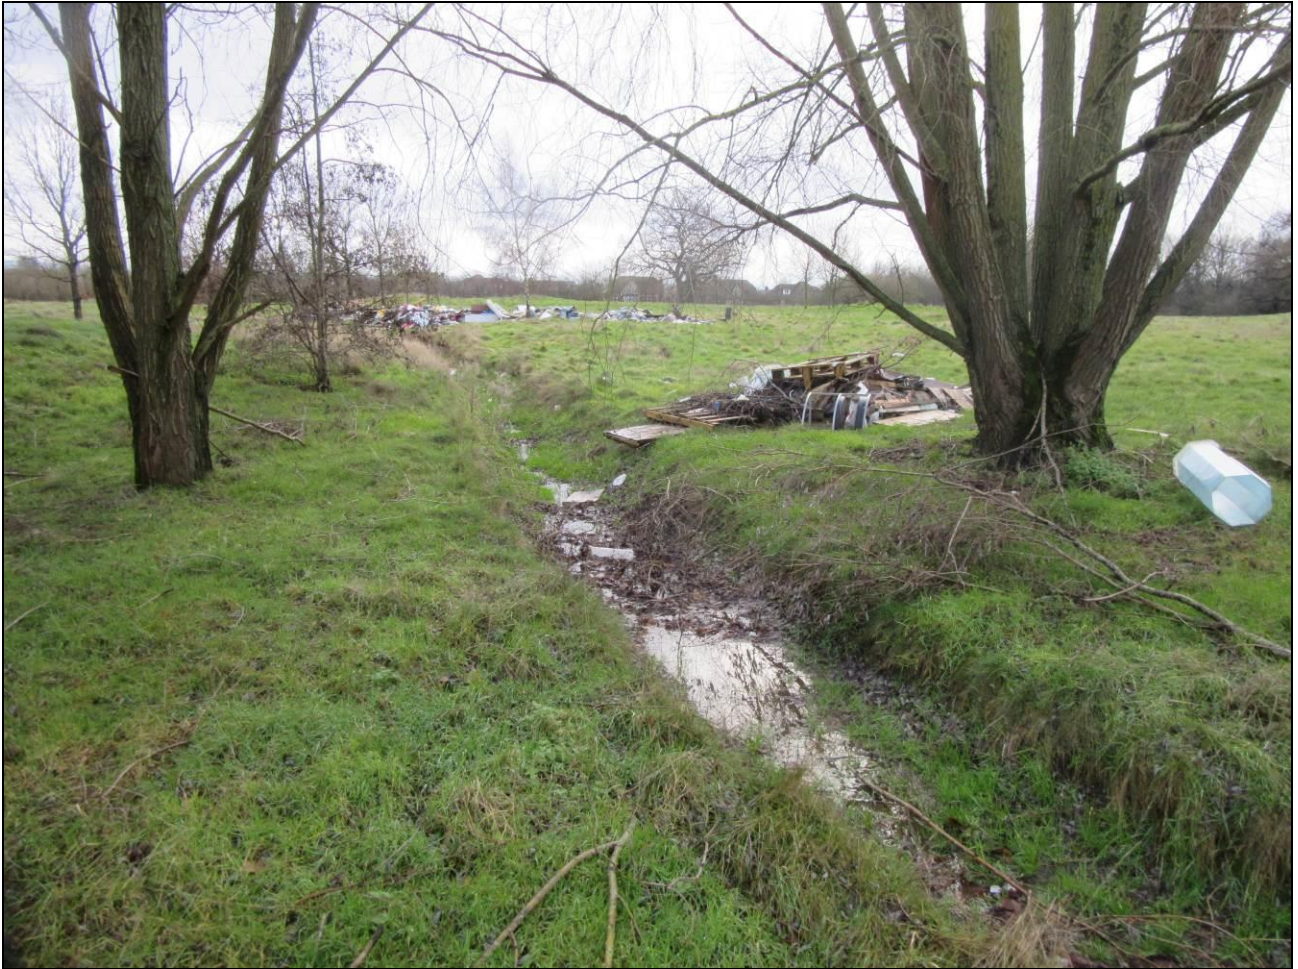
Photograph H – Showing Willows within G5 and their association with the existing drainage ditch.
